**Schedule B Municipal Class Environmental Assessment**  
**– Project File**  
**Mount Joy Creek Flood Mitigation**

**Aquafor Beech Limited**

The City of Markham (City) has commissioned Aquafor Beech Limited (Aquafor) to undertake a Municipal Class Environmental Assessment (MCEA) for the Mount Joy Creek corridor between Major Mackenzie Drive East and Bur Oak Avenue. This area is bordered between residential properties to the west and a Metrolinx Rail Corridor to the east, as is illustrated in **Figure 1** below.

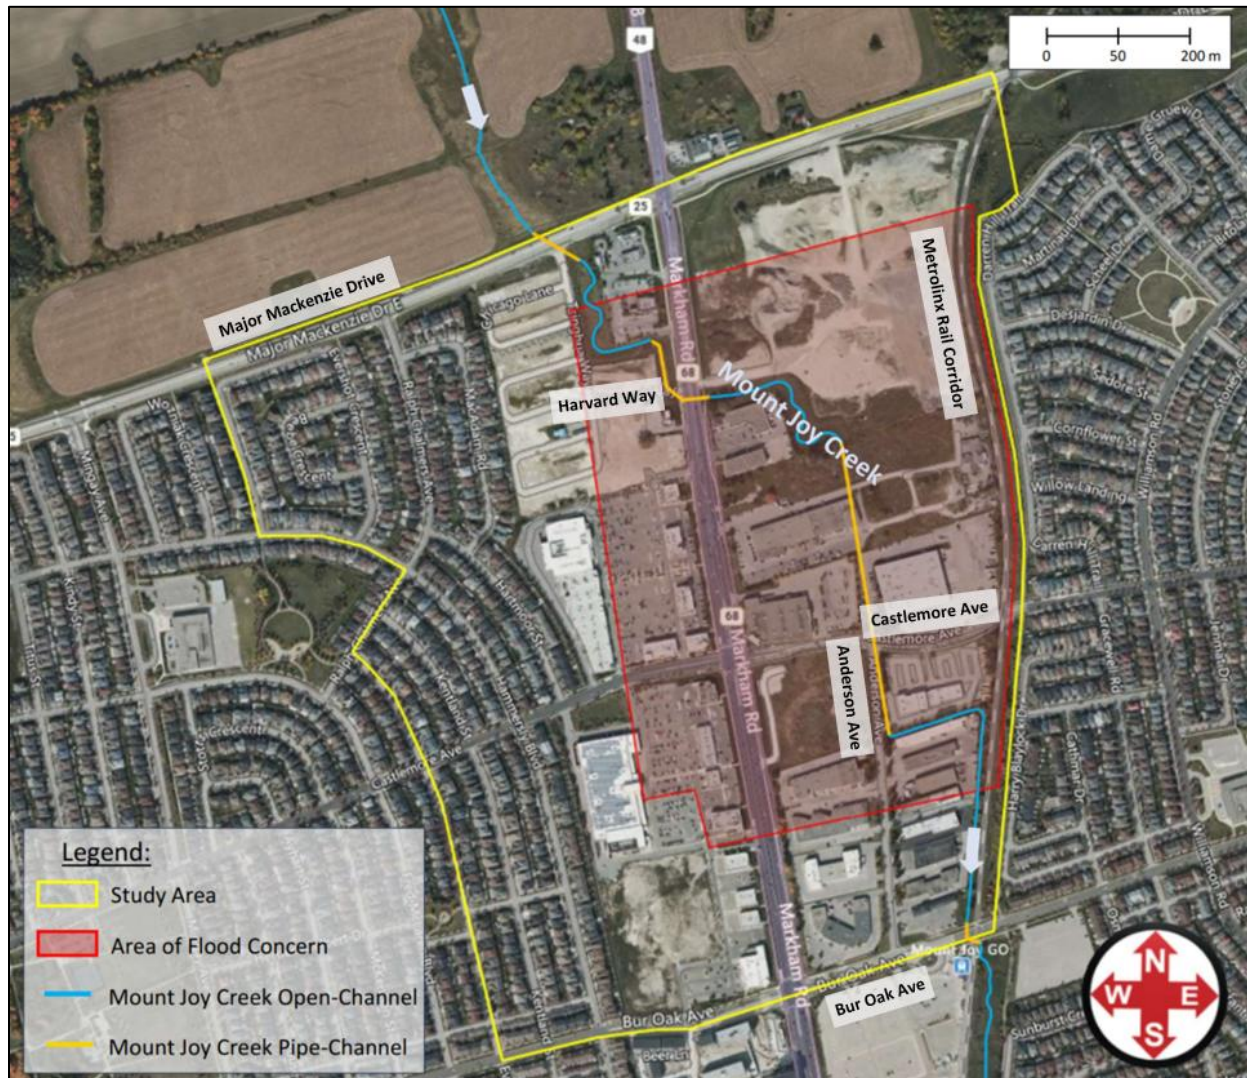
**Figure 1: Study Area for the Municipal Class Environmental Assessment at Mount Joy Creek**

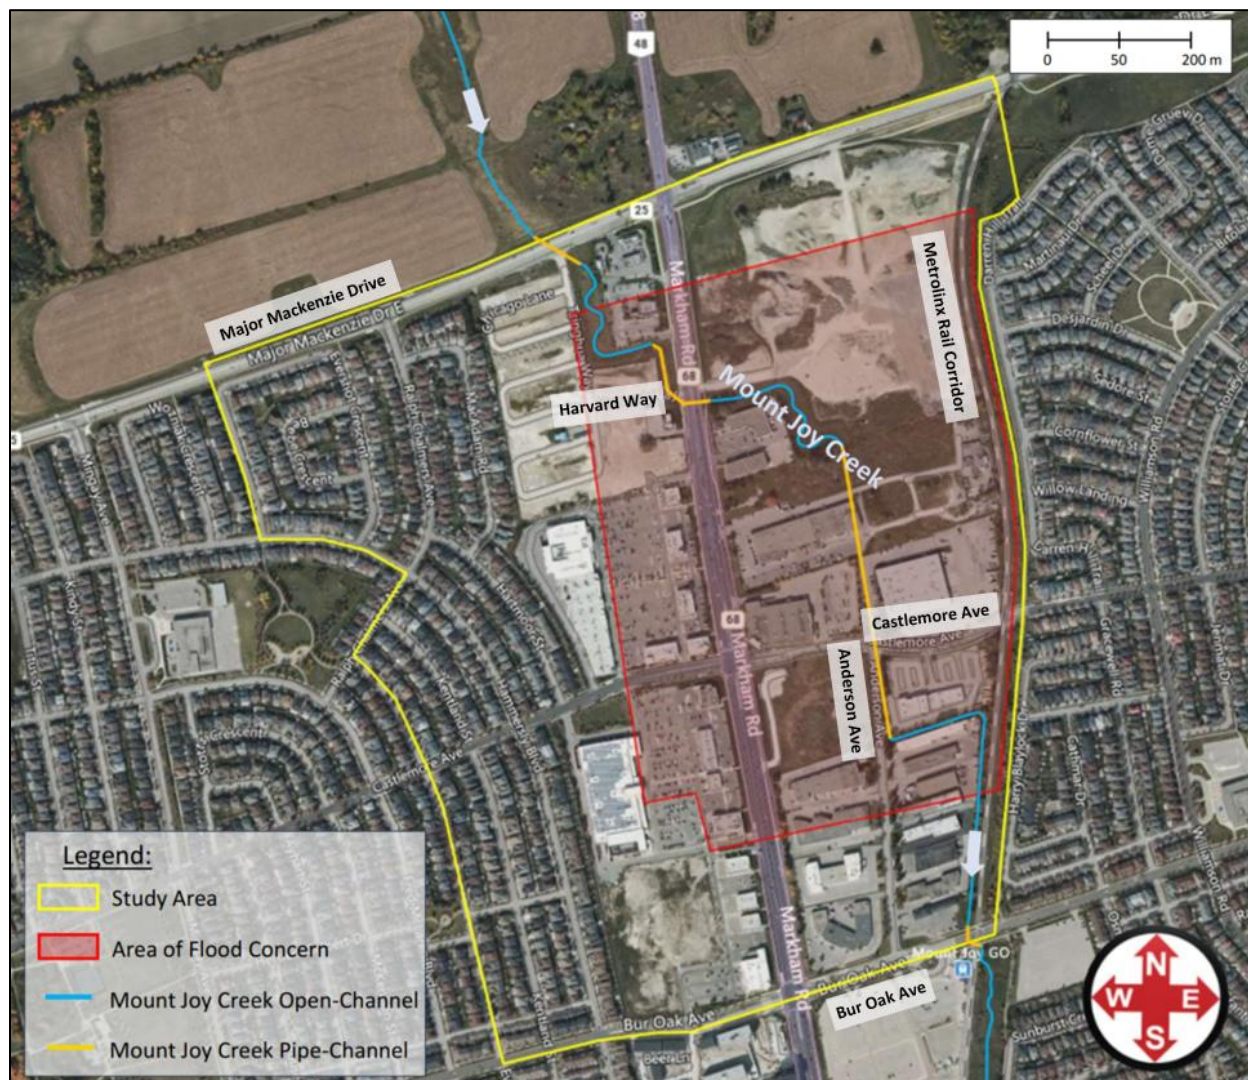
The study area for this Municipal Class Environmental Assessment (MCEA) encompasses a section of a residential area and industrial area located in the Mount Joy Creek (Exhibition Creek) corridor. The watercourse is located between Major Mackenzie Drive and Bur Oak Avenue for the Northern and Southern limits, and between Kentland Street and Metrolinx Railway corridor for the western and eastern limits. Within this area, Mount Joy Creek is an intermittent watercourse with a combination of piped and open channel segments causing reoccurring tableland flooding problems. **Figure 1-1** below provides a general overview of the study area extents.

**Figure 1-1: Mount Joy Creek Flood Mitigation Study Area**

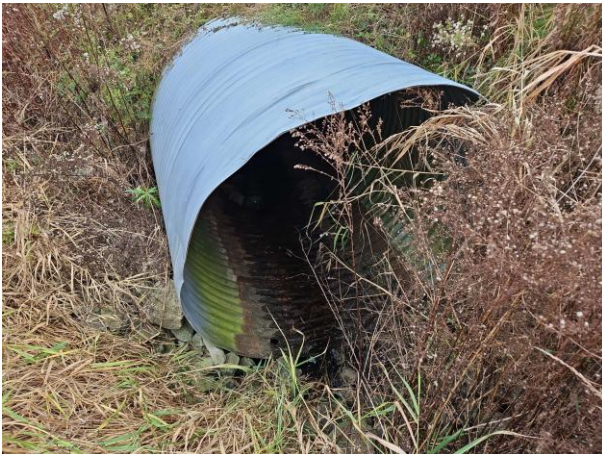
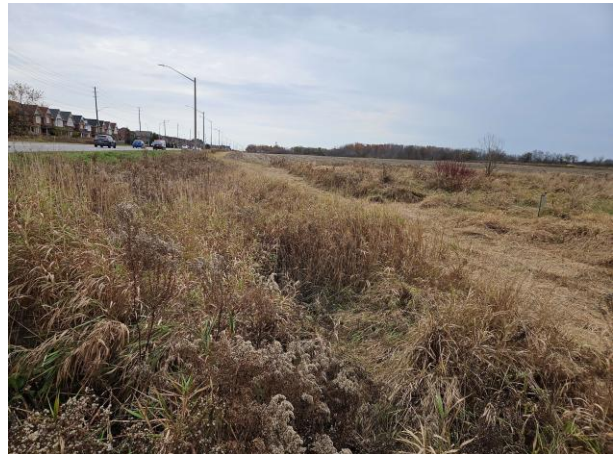
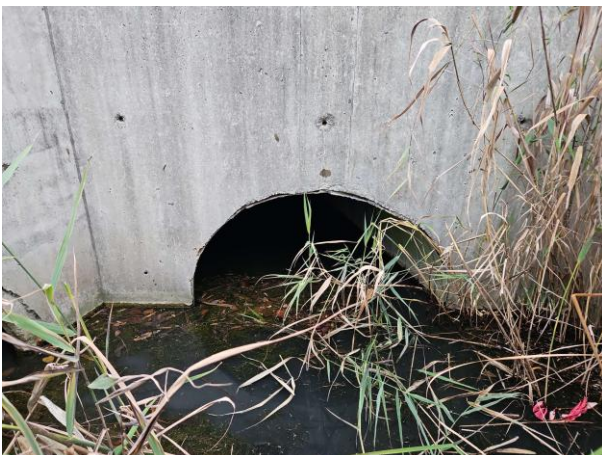
Mount Joy Creek travels through Major Mackenzie Drive East using a culvert. This corrugated steel pipe (CSP) culvert is approximately 75 metres in length and has a diameter of 1500 mm. The culvert is projected at the upstream end and is connected to a concrete headwall at the downstream extents. Concrete wingwalls extend from the headwall at both a 0° and 90° angle. No inlet or outlet grates were seen on the culvert. There were no signs of erosion at the culvert although extensive vegetated growth may have obscured localized erosion. Photos of the structure are shown in **Figure 2-2** to **Figure 2-5**.

**Figure 2-2: Major Mackenzie Drive East Upstream Culvert Face**

**Figure 2-3: Major Mackenzie Drive East Upstream Channel**

**Figure 2-4: Major Mackenzie Drive East Downstream Culvert Face**

**Figure 2-5: Major Mackenzie Drive East Downstream Channel**

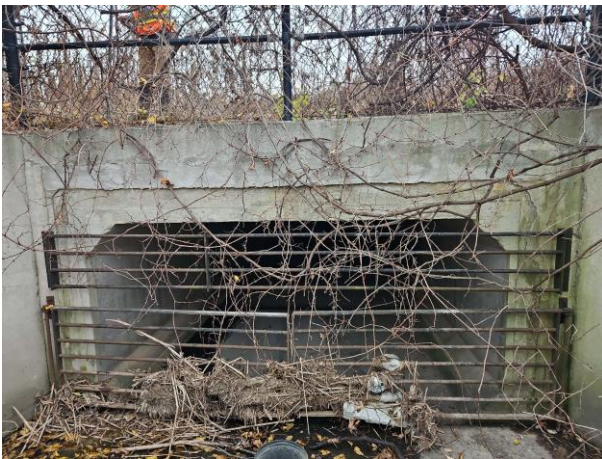
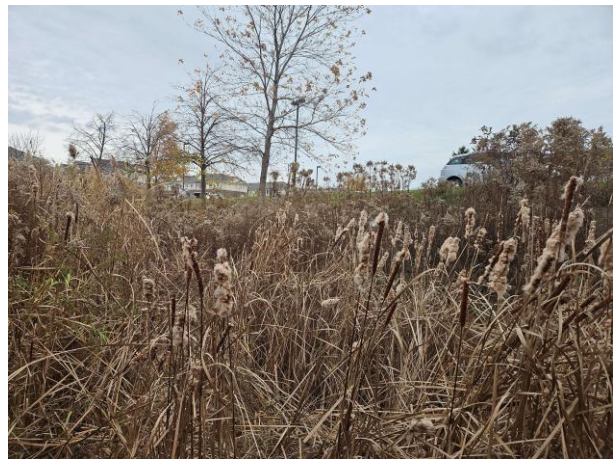
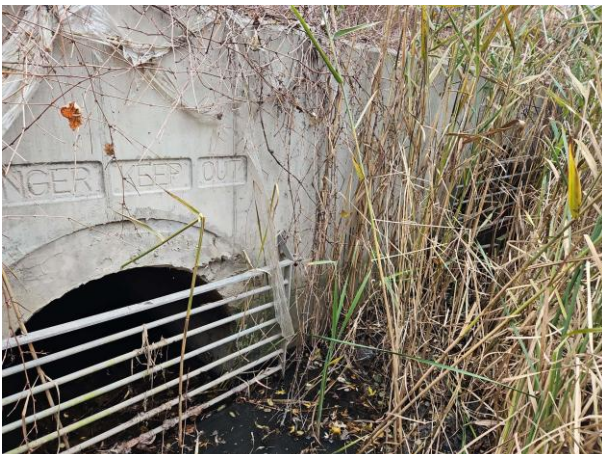
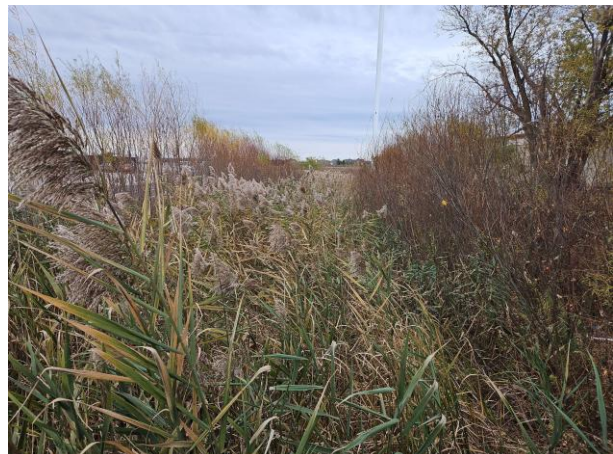
Mount Joy Creek enters a culvert upstream of Harvard Way, travels underneath Harvard Way and Markham Road, and enters open channel conditions downstream of Markham Road. This segment of the watercourse enters piped conditions for approximately 130 metres. The culvert inlet is a 1500 mm (height) x 3000 mm (span) box culvert with a concrete headwall and wingwall. In between Markham Road and Harvard Way, the culvert transitions from a 1500 mm x 3000 mm box culvert with three (3) 45° bends to two (2) circular culverts. The two (2) circular culverts are 1500 mm and 1050 mm in diameter. At the outlet, these circular culverts connect to a concrete headwall and wingwall. Both the culvert inlet and outlet have grates. There wasn't any erosion present at the culvert inlet or outlet however, vegetated growth may have obstructed erosion. Select photos of the culvert are shown in **Figure 2-6** to **Figure 2-9**.

**Figure 2-6: Harvard Way  
Upstream Culvert Face**

**Figure 2-7: Harvard Way  
Upstream Channel**

**Figure 2-8: Markham Road  
Downstream Culvert Face**

**Figure 2-9: Markham Road  
Downstream Channel**

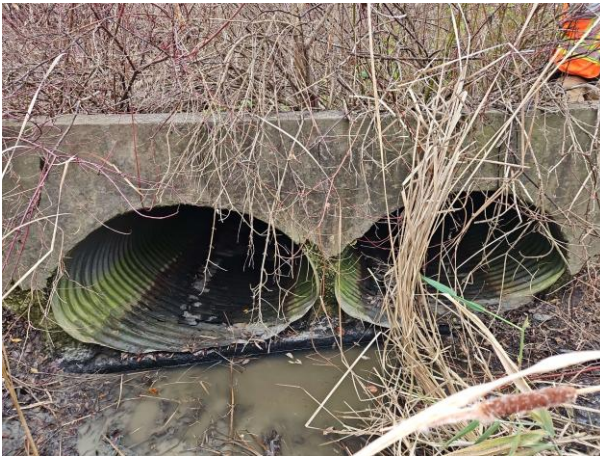
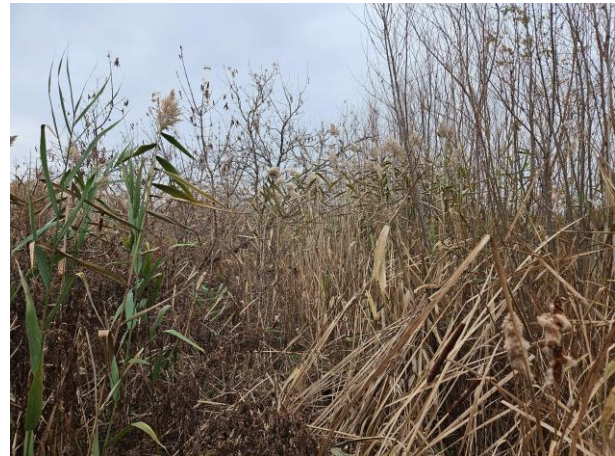
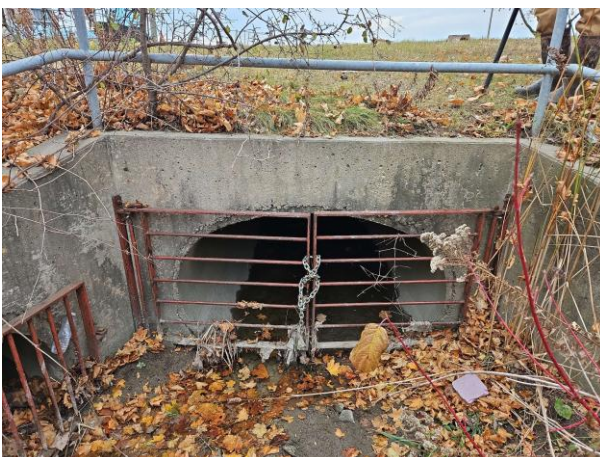
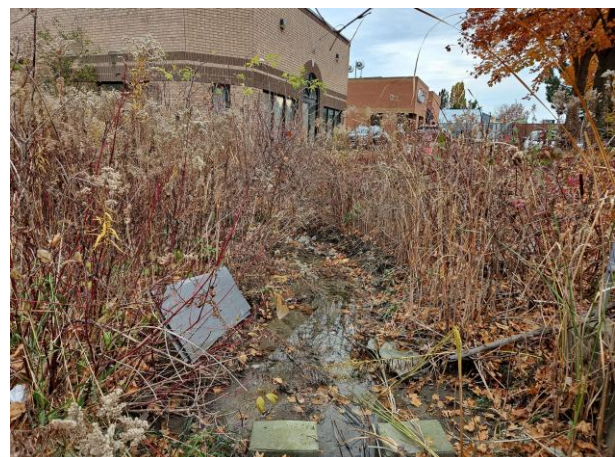
Mount Joy Creek enters a culvert upstream of Anderson Avenue, travels underneath Anderson Avenue and Castlemore Avenue, and enters open channel conditions downstream of Anderson Avenue. This segment of the watercourse enters piped conditions for approximately 320 metres. The culvert inlet is a twin 900 mm (height) x 1450 mm (span) CSP arch culvert with a concrete headwall. While underground, the culvert transitions from a twin arch culvert to a single 1100 mm (height) x 1700 mm concrete arch culvert. At the outlet, the culvert connects to a concrete apron. The concrete apron is also connected to an outfall and an energy dissipator device. An outlet grate is attached to the outlet of the culvert however; there isn't an inlet grate at the upstream face. There wasn't any channel erosion present at the culvert inlet or outlet however, vegetated growth may have obstructed erosion. There was some erosion behind the headwall at the culvert inlet and sections of the headwall have been disintegrate. Select photos of the culvert are shown in **Figure 2-10** to **Figure 2-13**.

**Figure 2-10: Upstream Culvert Face  
(Near Anderson Avenue)**

**Figure 2-11: Upstream Channel  
(Near Anderson Avenue)**

**Figure 2-12: Downstream Culvert Face  
(Near Anderson Avenue)**

**Figure 2-13: Downstream Channel  
(Near Anderson Avenue)**

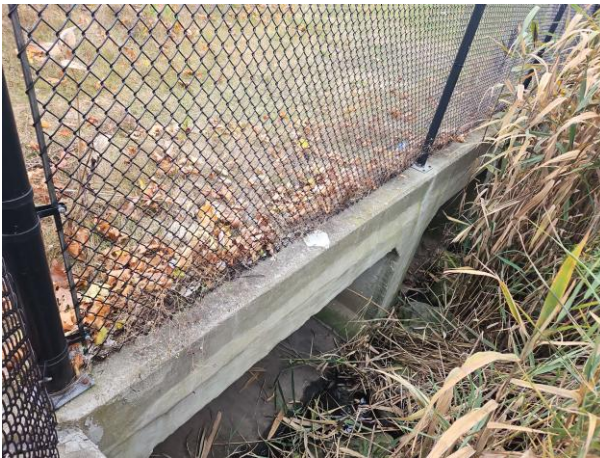
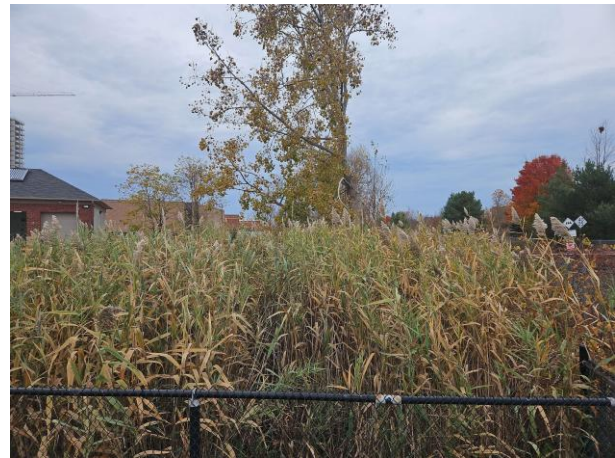
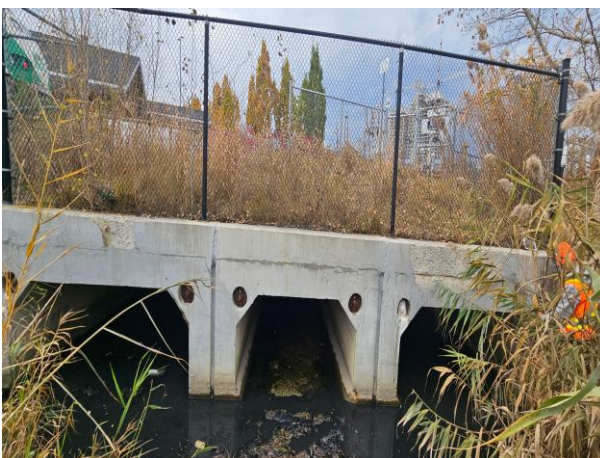
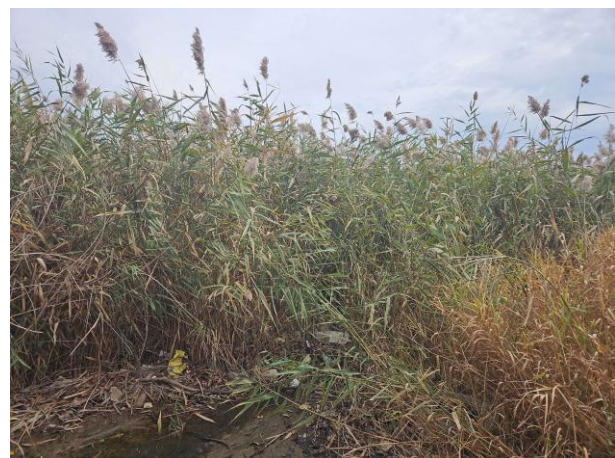
Mount Joy Creek travels through Bur Oak Avenue and a railway using three (3) box culverts. These box culverts are approximately 55 metres in length and are concrete box culverts. The size of the box culvert at the inlet is 1200 mm (height) x 2400 mm (span) and connects to a concrete headwall. At the outlet, the size of each box culvert changes to 1500 mm (height) x 2450 mm (span), 1200 mm (height) x 1800 mm (span), and 1200 mm (height) x 2400 mm (span). No inlet or outlet grates were seen on the culvert. There were no signs of erosion at the culvert although extensive vegetated growth may have obscured localized erosion. Field staff noted that there was a significant bend on the inside of the culvert. Photos of the structure are shown in **Figure 2-14** to **Figure 2-17**.

**Figure 2-14: Bur Oak Avenue  
Upstream Culvert Face**

**Figure 2-15: Bur Oak Avenue  
Upstream Channel**

**Figure 2-16: Bur Oak Avenue  
Downstream Culvert Face**

**Figure 2-17: Bur Oak Avenue  
Downstream Channel**

Field investigations were carried out by Valdor in December 2022 to confirm culvert configurations, dimensions, and physical characteristics. The measured dimensions were compared with those provided in the approved TRCA model. Findings indicated that the pipe extensions installed to the east of the original 1500 mm and 1050 mm pipes are constructed of concrete rather than steel, as assumed in the TRCA model. Further details are provided in **Section 3.5.2**.

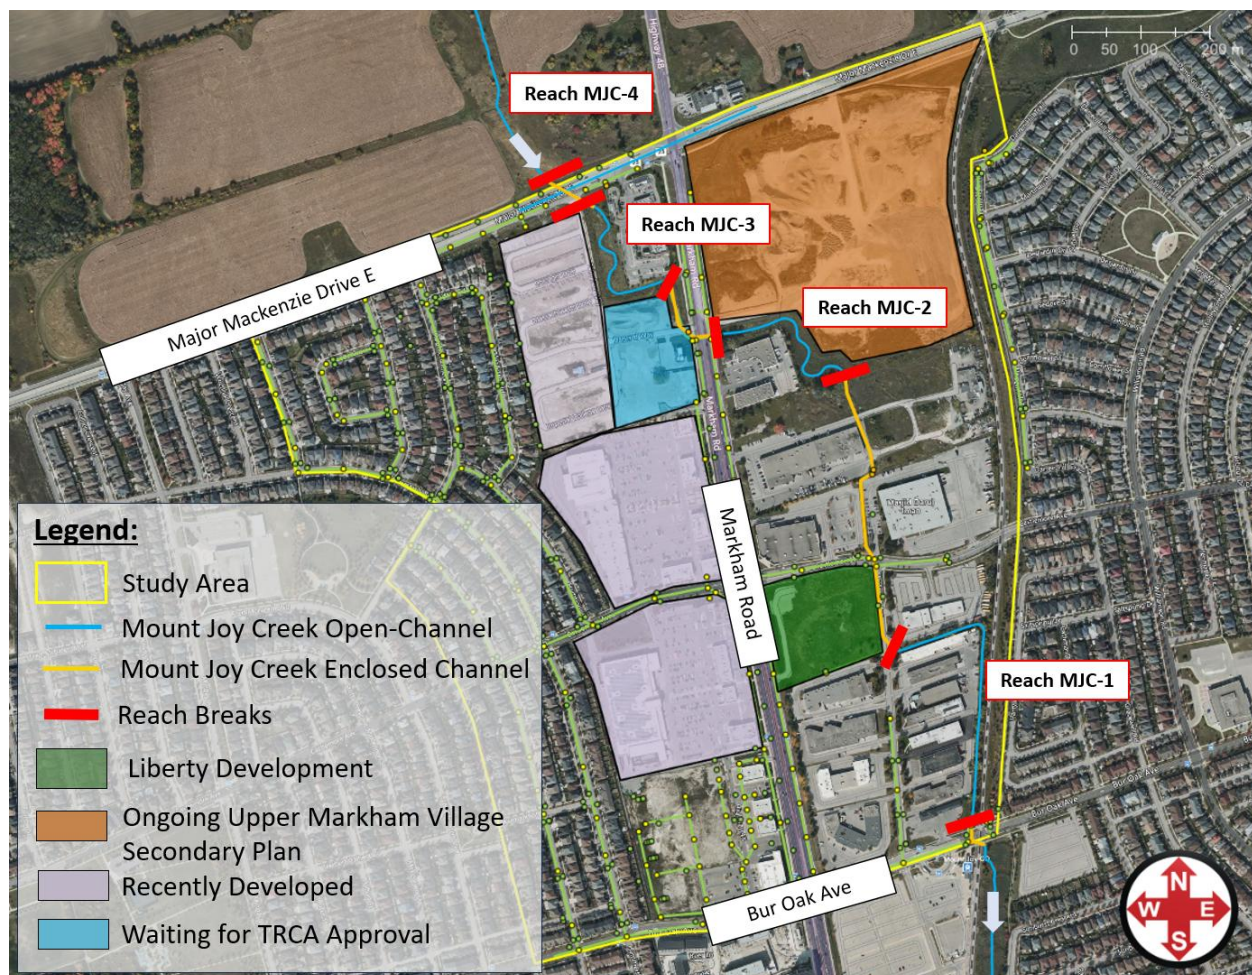
Majority of the channel and channel corridor through the study area is infilled with the invasive vegetation species, known as Phragmites. Due to this, processes of aggradation are present throughout the study area. While inherent erosional and aggregational processes are expected in a natural watercourse; these can be exacerbated by urbanization within a catchment area through alteration of the watercourse and changes in the rainfall-runoff response due to decreased infiltration. The existing fluvial conditions for each reach have been summarized in the sections below, accompanied by representative photographs.

**Figure 3-1: Delineated Reaches within the Mount Joy Creek Study Area**

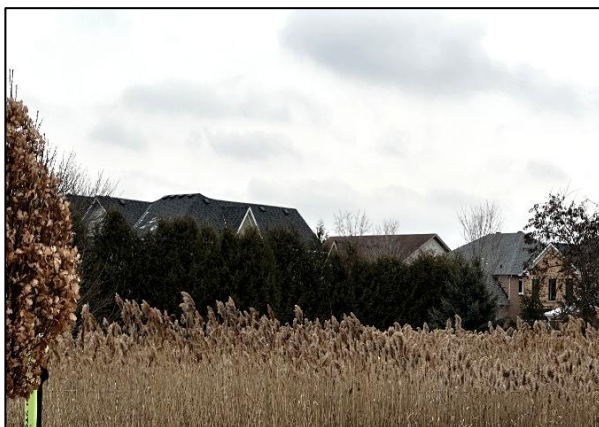
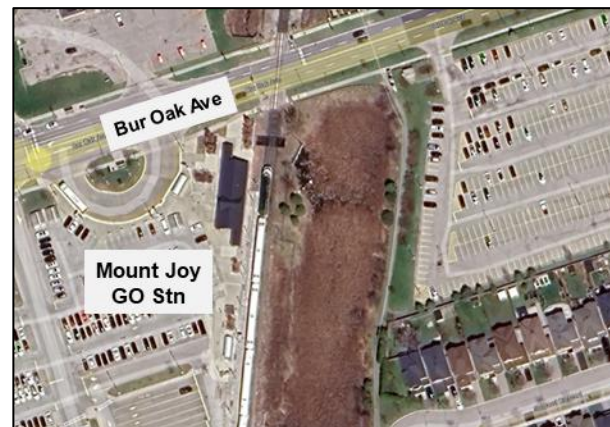
Mount Joy Creek, downstream of the study area, bypasses underneath Bur Oak Avenue and is outlet through a triple box culvert into a 30- to 40-metre-wide corridor which trends north to south. The corridor is surrounded by the Mount Joy GO Station parking lot and rail line to the west and, some parking and primarily residential land use to the east. The conditions downstream of the road consist of poor channelization of the creek where Phragmites have established and occupied the entire width of the corridor. The creek through this corridor extends approximately 570 m through the Phragmites downstream to a Storm Water Management (SWM) facility, and although appears to be primarily single-threaded, likely transitions to multi-threaded throughout some parts of the corridor. **Figure 3-2** shows the un-channelized reach through the Phragmites infested channel corridor from the west side looking from the Mount Joy GO Station parking lot in January 2025. Similar conditions can be seen in April 2024 (**Figure 3-3**) where the extent of the Phragmites through the wide corridor can be seen on aerial imagery.

**Figure 3-2: Looking east from Mount Joy GO Station at the un-channelized reach showing Phragmites infested channel corridor (January 2025)**

**Figure 3-3: Aerial view of Phragmites infilled channel corridor downstream of Bur Oak Avenue (Google Earth, April 2024)**

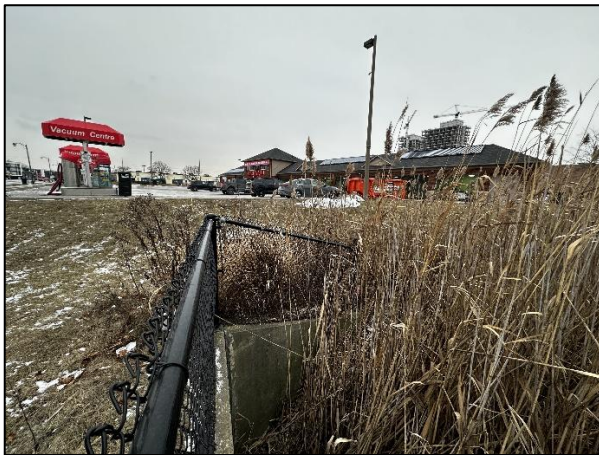
Reach MJC-1 is approximately 420 metres in length and extends from the Bur Oak Avenue culvert (**Figure 3-4**) upstream to the Anderson Avenue culvert. The bank material predominantly consists of sandy loam with silt. The bed material consists of fine to medium sand with silt. The average bankfull width is 3.5 metres and the average bankfull depth ranges between 0.6 metres to 0.8 metres. The channel through this reach is surrounded by industrial land use on either side. In particular, the 290-metre-long segment which runs in the north-south direction is surrounded by industrial property parking lot to the west and Railway Corridor on the east. Similarly, the 130-metre-long segment of the reach which runs in the east-west direction is confined by industrial building to the south – being within less than 1 metre of the watercourse – and a steep valley wall supporting the parking lot and buildings to the north.

**Figure 3-4: Upstream side of Bur Oak Ave culvert, facing west towards Carwash**

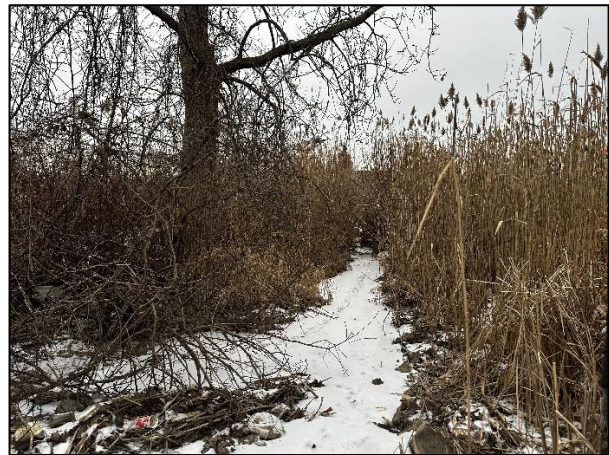
**Figure 3-5: Looking downstream at start of Phragmites lining the channel**

This reach of Mount Joy Creek has been historically straightened and consists of a very narrow riparian corridor. The reach is channelized with no floodplain and the channel exhibits shallow pool – riffle morphology. The extent of the Phragmites at the downstream extent is approximately 20 metres where the channel narrows to ~ 1.5 metres through the dense vegetation growth (**Figure 3-5**). The segment of the channel trending north-south is within 1 metre of the commercial property parking lot (**Figure 3-6**). A severe woody debris jam can be seen in **Figure 3-7** due to leaning and fallen trees within the segment of the channel trending east-west. Within this upstream section, the southern channel top of bank as seen in **Figure 3-8** is within 1 metre of the commercial building posing erosional risks. Weir structure is located downstream of the Anderson Avenue culvert to act at energy dissipation structures.

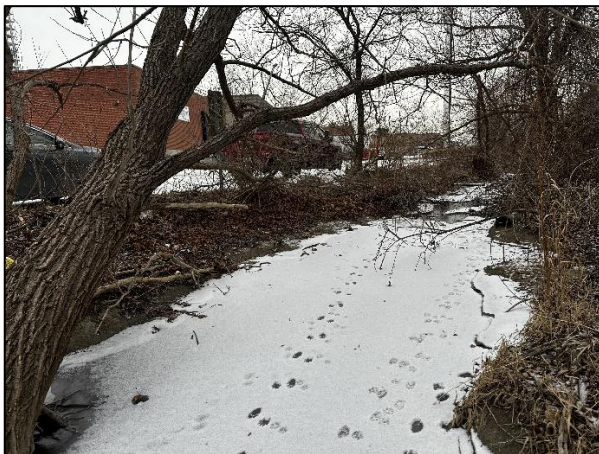
**Figure 3-6: Looking upstream at channel in close proximity to parking lot**

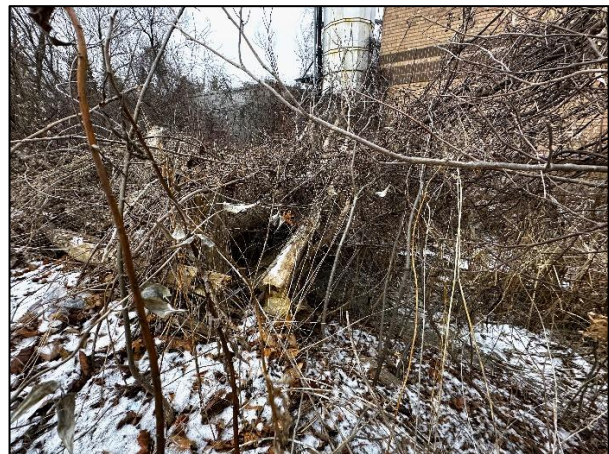
**Figure 3-7: Severe woody debris jam due to leaning and fallen trees**

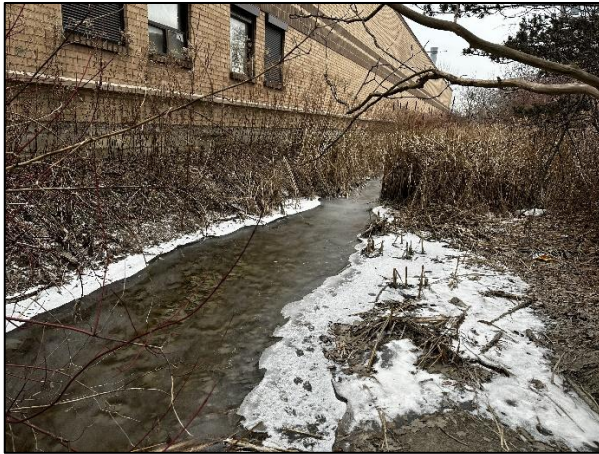
**Figure 3-8: Looking upstream at channel south bank within 1 m of commercial buildings**

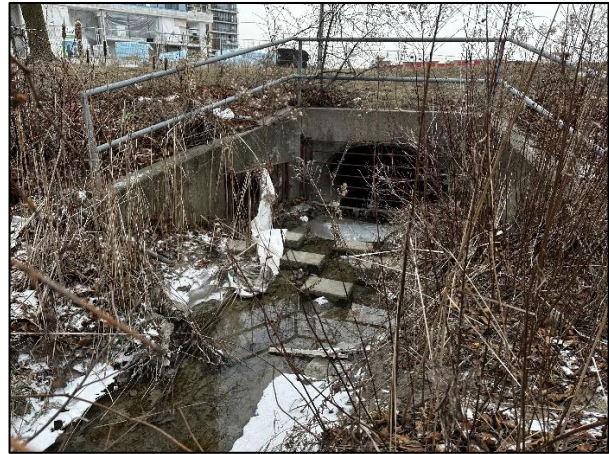
**Figure 3-9: Anderson Ave culvert at upstream extent of the reach**

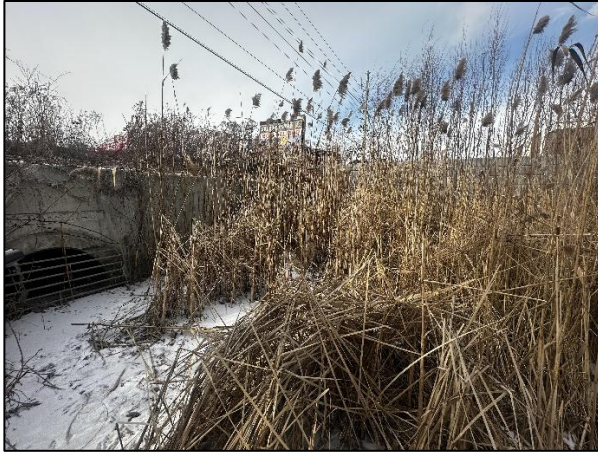
Although some channel morphology is visible including the channel banks and bed, the reach is infilled with Phragmites which start upstream at the Markham Road (**Figure 3-10**). The channel is unconfined where it borders commercial properties to the west and south, and the areas north and east of the reach are under construction. The exposed section of Mount Joy Creek channel can be seen in **Figure 3-11** where less Phragmites are present and channel banks and bed can be visible. The tributary of Mount Joy Creek joining from the west at the downstream extent of the reach can be seen in **Figure 3-12** which is approximately 1.5 metres in bankfull width and 0.8 metres in bankfull depth. At the same location, the twin CSP culvert with concrete headwall at the downstream extent of the reach can be seen in **Figure 3-13**. The deteriorated culvert has been undermined and outflanked due to the increased flow from the tributary. This is discussed in further detail in **Section 3.1.3.2**.

**Figure 3-10: Looking upstream at the twin culvert with concrete headwall and the start of Phragmites within the reach**

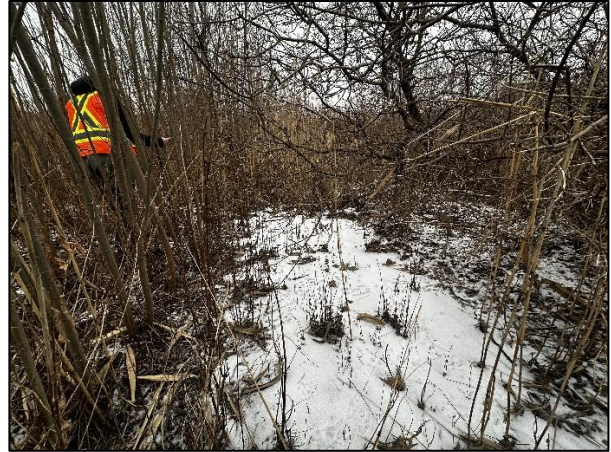
**Figure 3-11: Looking upstream at the exposed section of Mount Joy Creek channel where less Phragmites are present**

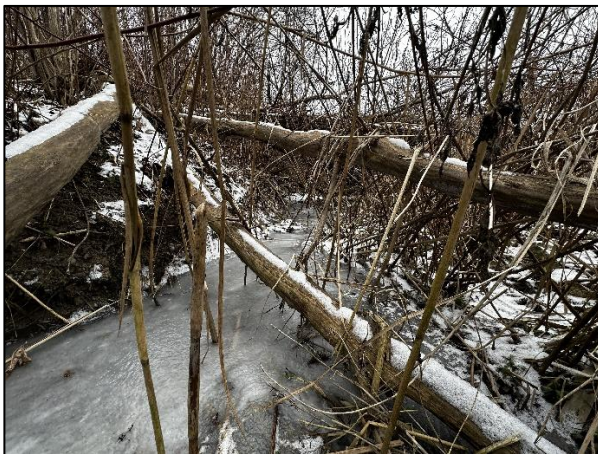
**Figure 3-12: Looking upstream at the tributary of Mount Joy Creek joining from the west at the downstream extent of the reach**

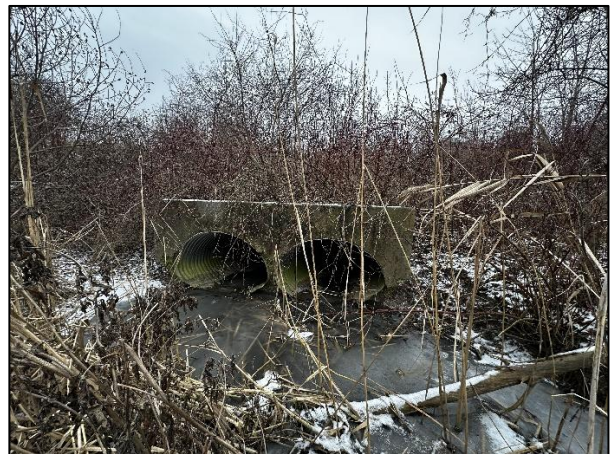
**Figure 3-13: Deteriorated twin CSP culvert with concrete headwall at the downstream extent of the reach**

Erosion Site 2 is located at the downstream-most extent of Reach MJC-2 and is characterized by a deteriorated twin CSP culvert with concrete headwall (**Figure 3-24**). The site exhibits severely undermined and outflanked concrete headwall and CSP culvert where the exposed CSP and deteriorated concrete casing behind the headwall can be seen in **Figure 3-25**. The concrete headwall is at a risk of collapsing due to its outflanked and undermined base and sides. A tributary of Mount Joy Creek can be seen in **Figure 3-26** joining from the west at the confluence. It may be contributing significant flow to the system which is directed at the base of the culvert with no erosion protection in place, leading to the outflanking and undermining of twin culvert overtime. Along with the culvert, the banks of the tributary are also experiencing severe erosion with leaning and fallen trees seen within tributary channel. This is indicative of high flow velocities and shear within the tributary. In comparison, the flows within Mount Joy Creek may be lower as no active erosion is seen within the channel, which in fact is undergoing processes of severe aggradation. The conditions of Mount Joy Creek surrounded by a wooded riparian corridor upstream of the deteriorated culvert can be seen in **Figure 3-27** where approximately 30 metres of the 260-metre-long reach is exposed and not infilled by *Phragmites*.

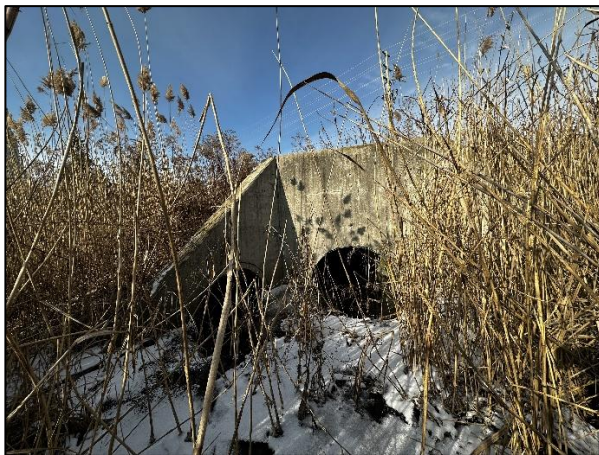
**Figure 3-14: CSP culvert with concrete headwall located at upstream extent of reach conveying flow under Major Mackenzie Road East**

A CSP culvert with concrete headwall located at upstream extent of reach conveying flow under Major Mackenzie Road East can be seen in **Figure 3-14**. Sediment accumulation can be seen throughout the reach where Phragmites have infilled the channel (**Figure 3-15**). **Figure 3-16** shows the upstream view from the Markham Road culvert at slight channelization seen within the densely vegetated channel corridor infilled with Phragmites. The concrete box culvert located at the downstream extent of the reach at Markham Road can be seen in **Figure 3-17**.

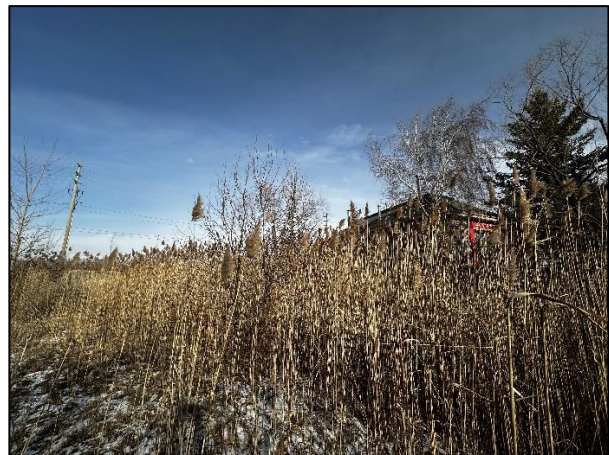
**Figure 3-15: Sediment Accumulation throughout reach where channel is infilled with Phragmites and some Cattails**

The reach has been historically modified with an engineered planform, gradient, and sinuosity. The modification resulted in an increase in sinuosity, and a decrease in gradient which has likely led to frequent ponding of water throughout the channel corridor resulting in sediment accumulation. As such, active channel bed aggradation has been occurring through the reach leading to poor flow conveyance. Further geomorphic adjustment in the form of aggregational processes is occurring as a result of urban hydromodification in response to higher peak flows, greater runoff volumes, and more frequent flow events bringing in more sediment. As the channel is filled with dense vegetation consisting primarily of Phragmites and some Cattails, this has further led to sedimentation accumulation of the channel bed and floodplain, leading to poor flow conveyance and flooding.

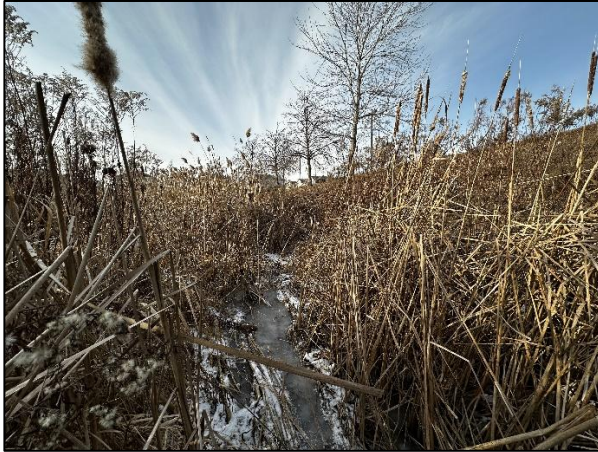
**Figure 3-16: Looking upstream from Markham Road culvert at slight channelization through dense Phragmites**

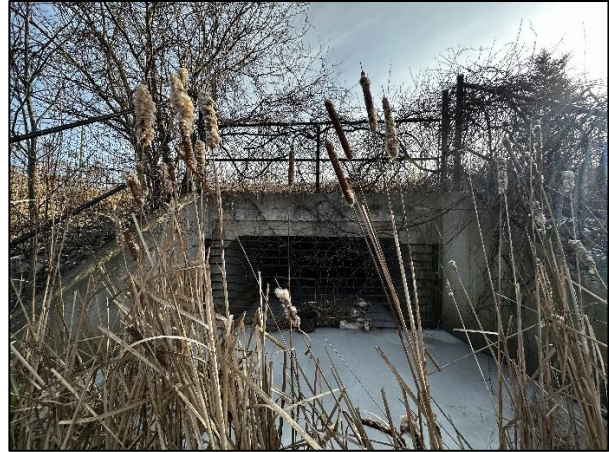
**Figure 3-17: Concrete box culvert located at the downstream extent of the reach at Markham Road**

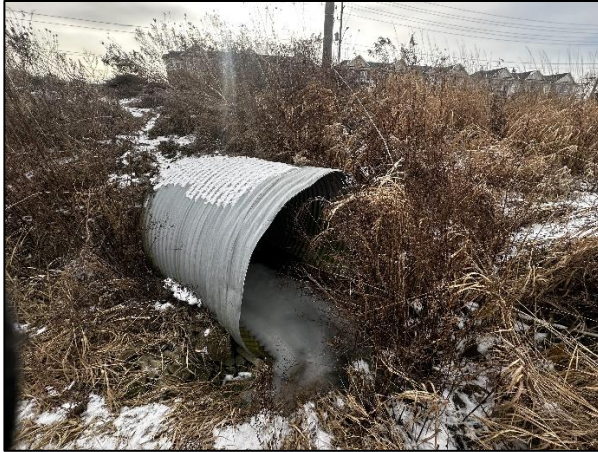
**Figure 3-18: Looking at the CSP culvert upstream of Major Mackenzie Drive East conveying flow from open agricultural land**

Reach MJC-4 extends upstream from Major Mackenzie Drive East CSP culvert approximately 145 metres to the farm crossing. The bank material consists of sandy loam and the bed material consists of fine to medium sand and sandy loam. The bankfull width ranges from 3 – 6 metres and the average bankfull depth is 0.5 metres. This reach lacks pool – riffle morphology and consists of low-lying areas where the watercourse transitions between channelized and un-channelized forms. Overall, the reach is characteristic of a poorly defined urban drainage ditch, with a heterogenous cross-sectional area along its length and intermittent access to the adjacent floodplain. Looking at the CSP culvert upstream of Major Mackenzie Drive East conveying flow from open agricultural land (**Figure 3-18**). The un-channelized portion of Reach MJC-4 within Mount Joy Creek can be seen in **Figure 3-19**. **Figure 3-20** shows the treeline and potentially channelized portion of the reach towards the east. The farm crossing located at the midpoint of the reach can be seen in **Figure 3-21**.

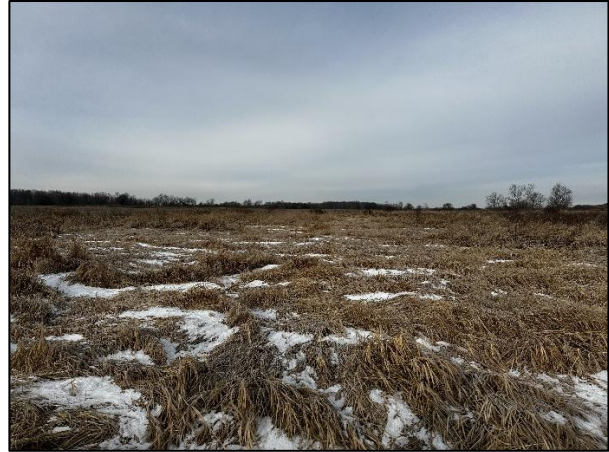
**Figure 3-19: Looking upstream at Reach MJC-4 at the un-channelized portion of Mount Joy Creek**

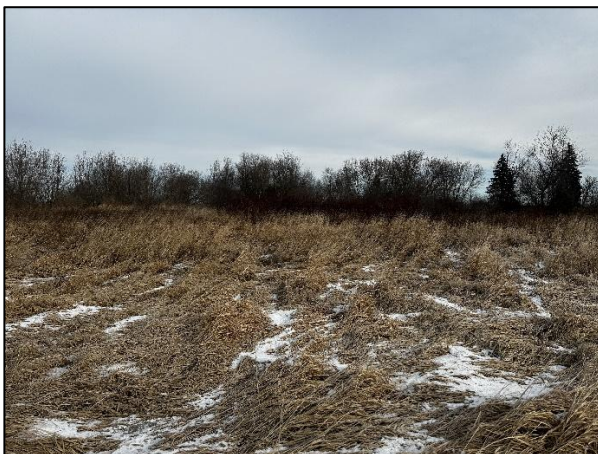
**Figure 3-20: Looking east towards treeline and potentially channelized portion of the reach**

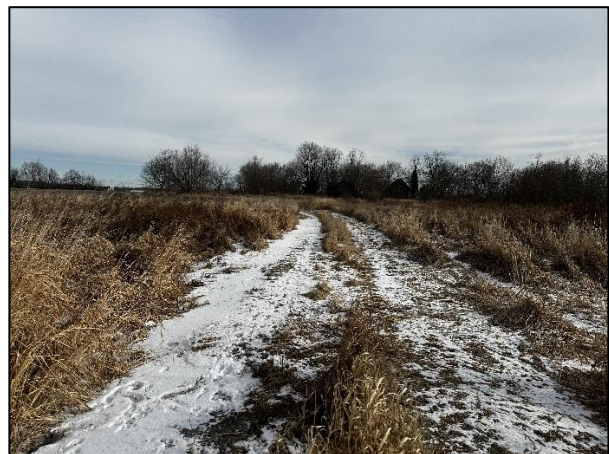
**Figure 3-21: Farm crossing located at the midpoint of the reach**

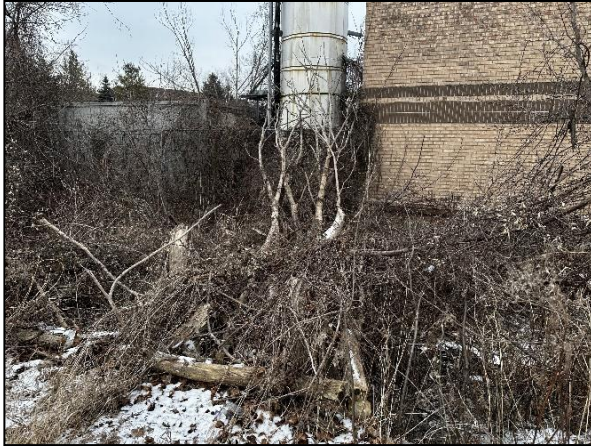
**Figure 3-22: Severe debris jam approx. 115 m downstream of Anderson Ave culvert**

Erosion Site 1 is located within Reach MJC-1 is located approximately 115 metres downstream of the Anderson Avenue culvert. It is characterized by a severe debris jam which consists of mature trees and woody vegetation (**Figure 3-22**) fallen into and on top of the channel. **Figure 3-23** shows the trees breaking from the top of slope and banks of the channel resulting in the debris jam. The creek at low flow, is not heavily impacted as the flow is able to be conveyed beneath the woody debris. During heavy flow and storm events, however, this could lead to severe backwatering of the channel resulting in flooding of the surrounding areas as it would obstruct flow within the channel. Here, the toe of the bank is within 1 – 2 metres of the building on the south bank and within ~ 4 metres of the parking lot on the north bank. Overtime, along with recurrent flooding, this could also lead to erosion of the toe of bank and slopes, leading to slope failure and putting adjacent parking lot, infrastructure, or building footings at risk.

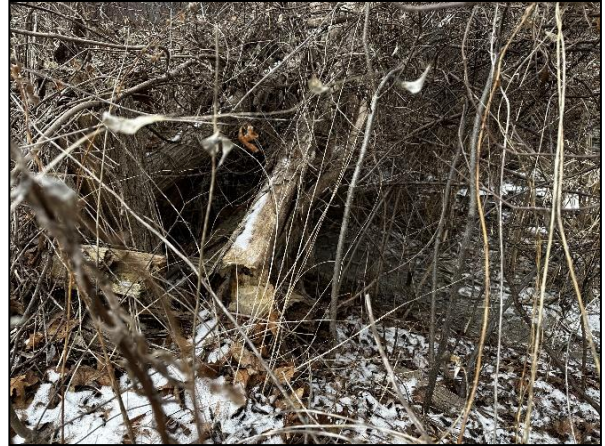
**Figure 3-23: Debris jam resulting from broken and fallen trees located at top of slope and channel banks**

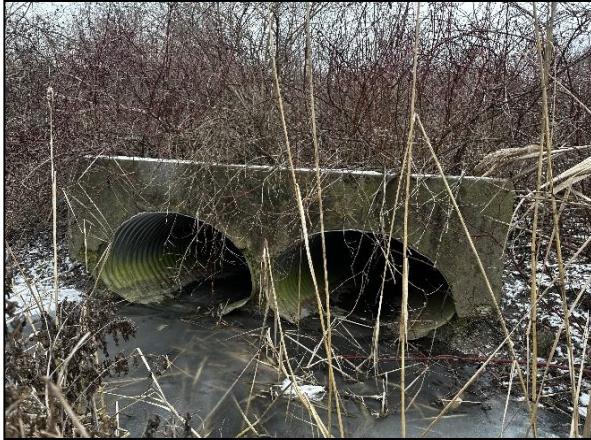
**Figure 3-24: Outflanked and undermined twin CSP culvert with Concrete Headwall at downstream end of Reach MJC-2**

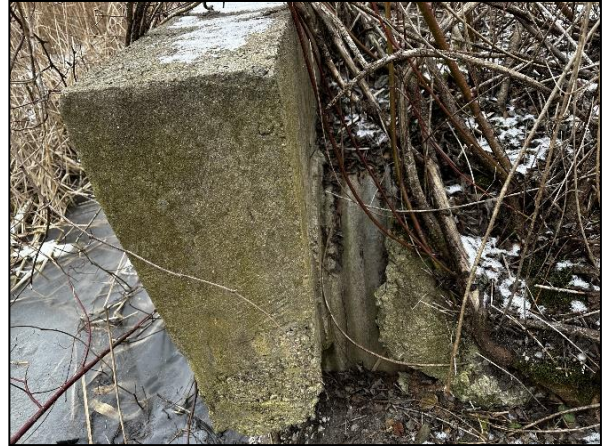
**Figure 3-25: Exposed CSP and deteriorated concrete casing behind the headwall**

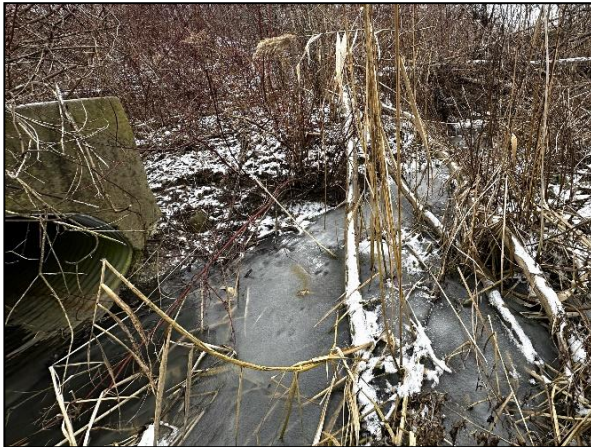
**Figure 3-26: Tributary of Mount Joy Creek from the west at downstream extent of reach; contributing significant flow directed at the culvert**

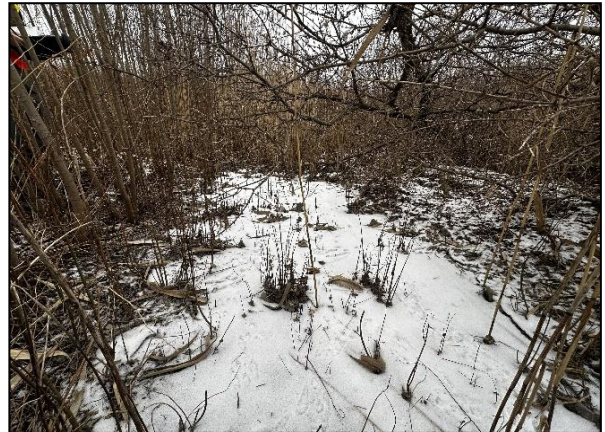
**Figure 3-27: Mount Joy Creek upstream of the deteriorated twin culvert surrounded by wooded riparian corridor**

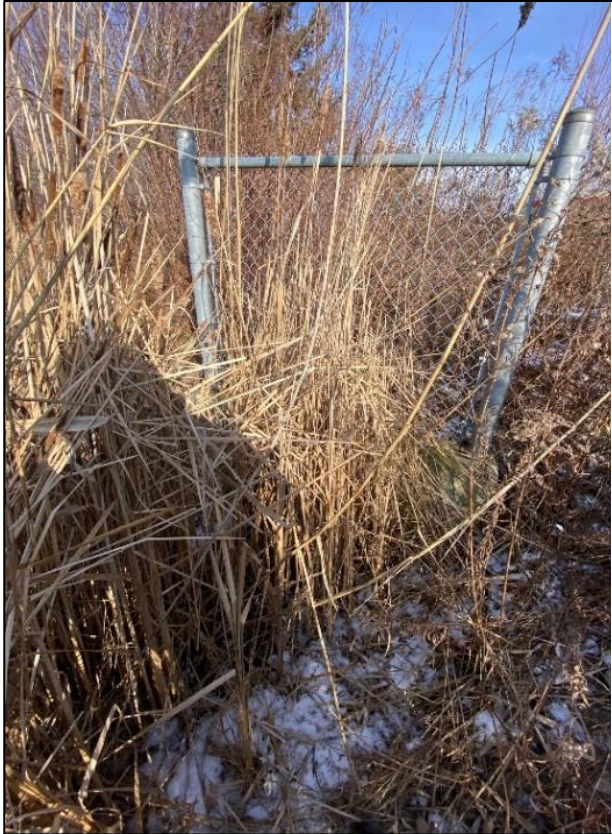
**Figure 3-28: Looking directly at the buried stormwater outfall with concrete headwall and fence**

Erosion Site 3 is located within Reach MJC-3 and is characterized by a buried and non-functional stormwater outfall with a concrete headwall and fence (**Figure 3-28**). The severe sediment accumulation within the channel (**Figure 3-29**) has led to the stormwater outfall to fill with sediment and the headwall to become partially buried. This outfall appears to be designed to convey runoff from the adjacent commercial properties to the east (**Figure 3-30**). As such, sediment accumulation within the outfall is likely resulting in the backwatering of the drainage system, and may be leading to the flooding observed within the area.

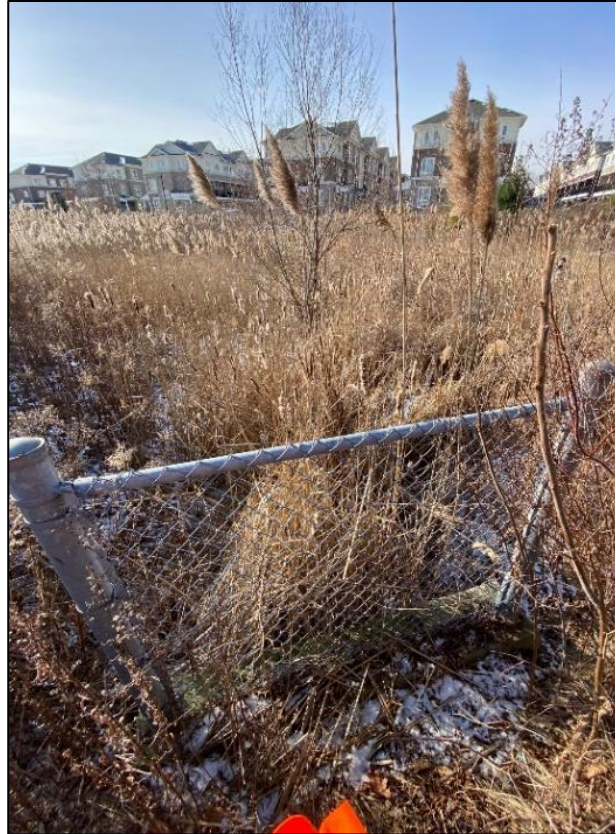
**Figure 3-29: Looking downstream from the buried stormwater outfall at the aggraded and Phragmites infilled channel**

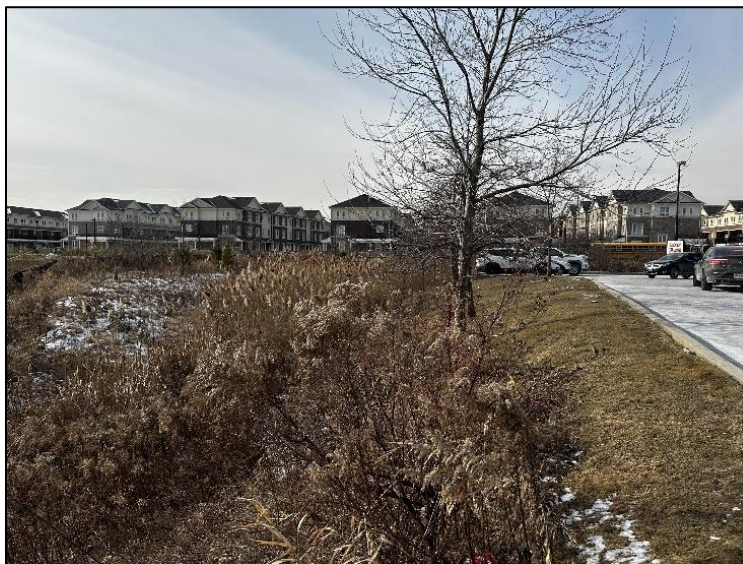
**Figure 3-30: Phragmites infilled channel adjacent to commercial properties and parking lot leading to increased drainage and run-off into the channel and the outfall**
