**Schedule B Municipal Class Environmental Assessment**  
**– Project File**  
**Mount Joy Creek Flood Mitigation**

**Aquafor Beech Limited**

The City of Markham (City) has commissioned Aquafor Beech Limited (Aquafor) to undertake a Municipal Class Environmental Assessment (MCEA) for the Mount Joy Creek corridor between Major Mackenzie Drive East and Bur Oak Avenue. This area is bordered between residential properties to the west and a Metrolinx Rail Corridor to the east, as is illustrated in **Figure 1** below.

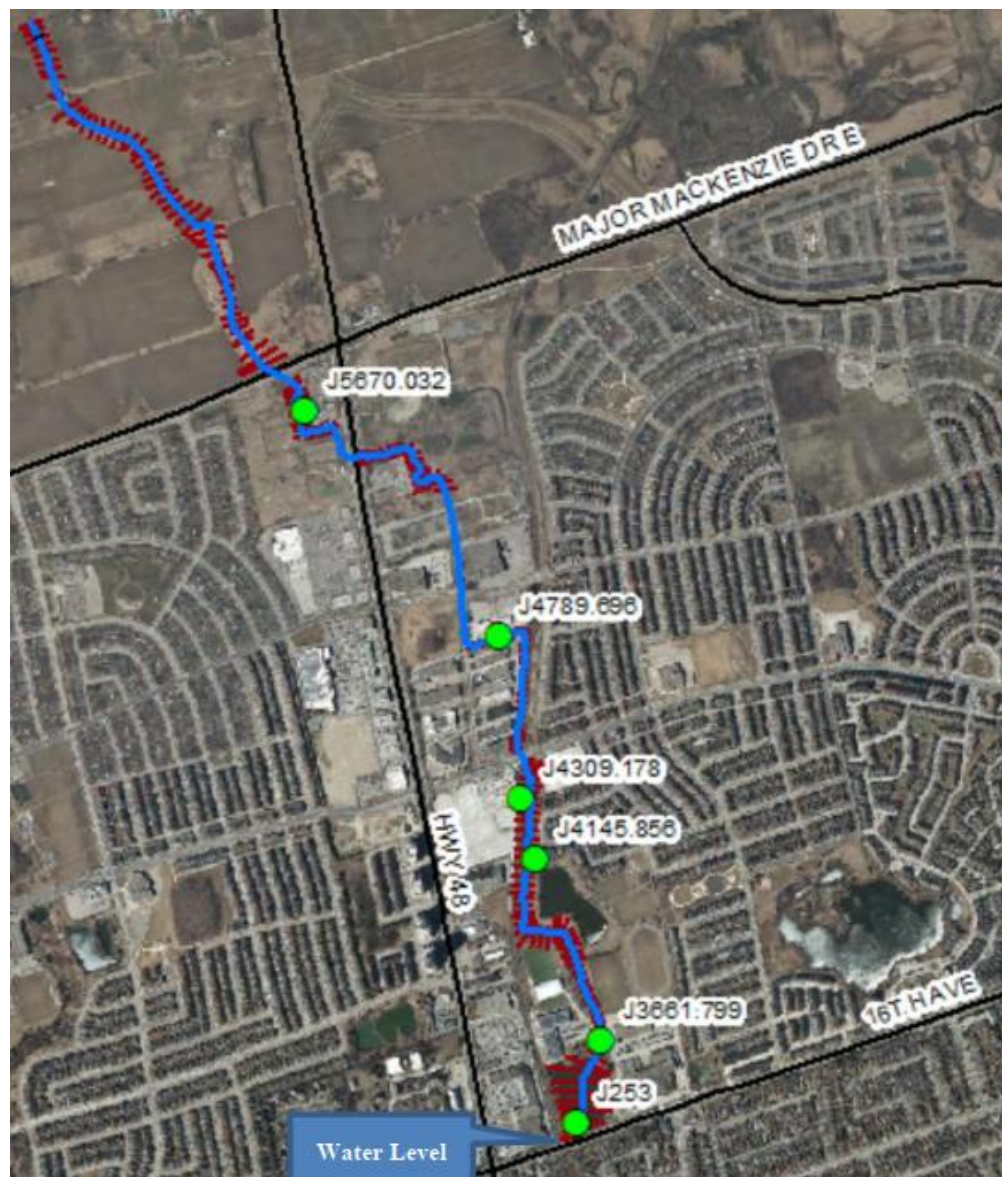
The specific locations of flow nodes, which include flood flows ranging from the frequent 2-year return through the 100 year and Regional are illustrated on the adjacent figure, with the pertinent flows summarized in **Table 3-6** below.

**Figure 3-42: MIKE Flood Hydrologic Flow Nodes (TRCA, 2022).**

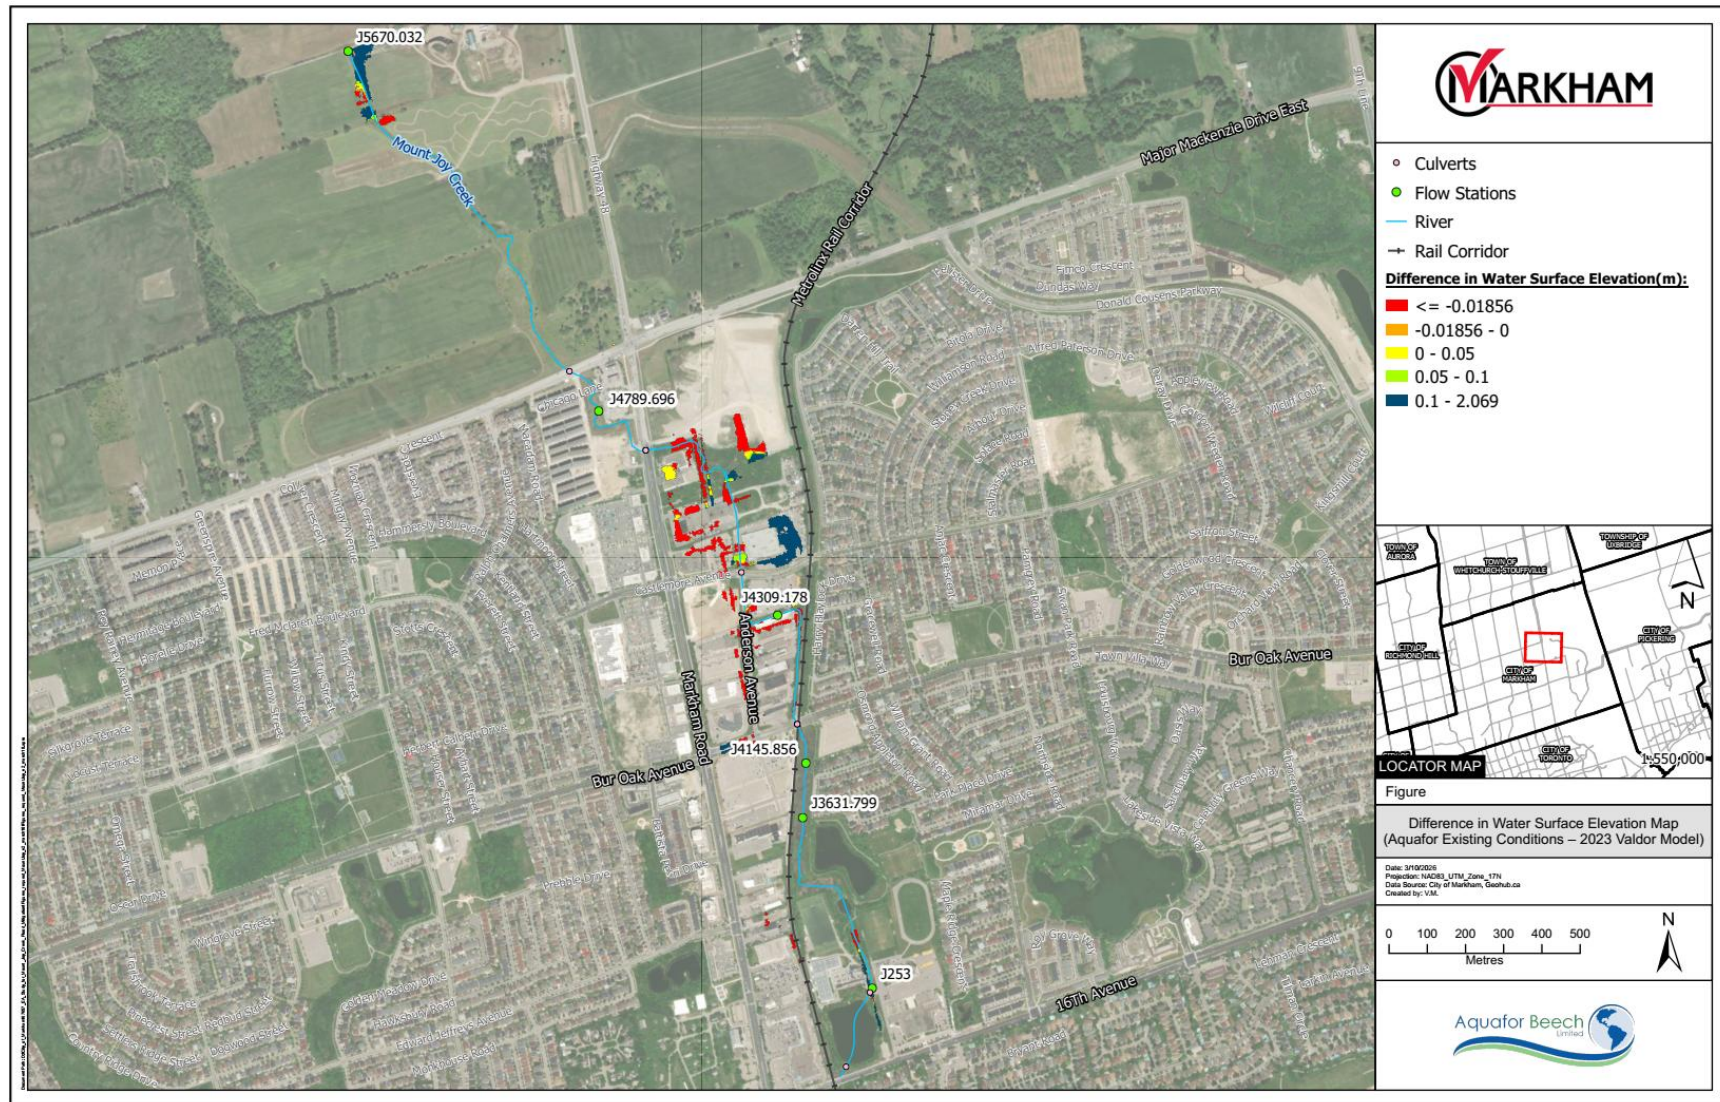
**Figure 3-51: Difference for Regional Water Surface Elevation between 2026 Aquafor Model and 2023 TRCA Model**

For reference, a comparison of the resulting WSELs from the MIKE+ converted model for the same area is provided in **Figure 3-50** and **Figure 3-51**. Comparison with Aquafor existing conditions model is provided in **Figure 3-50** and **Figure 3-51**.

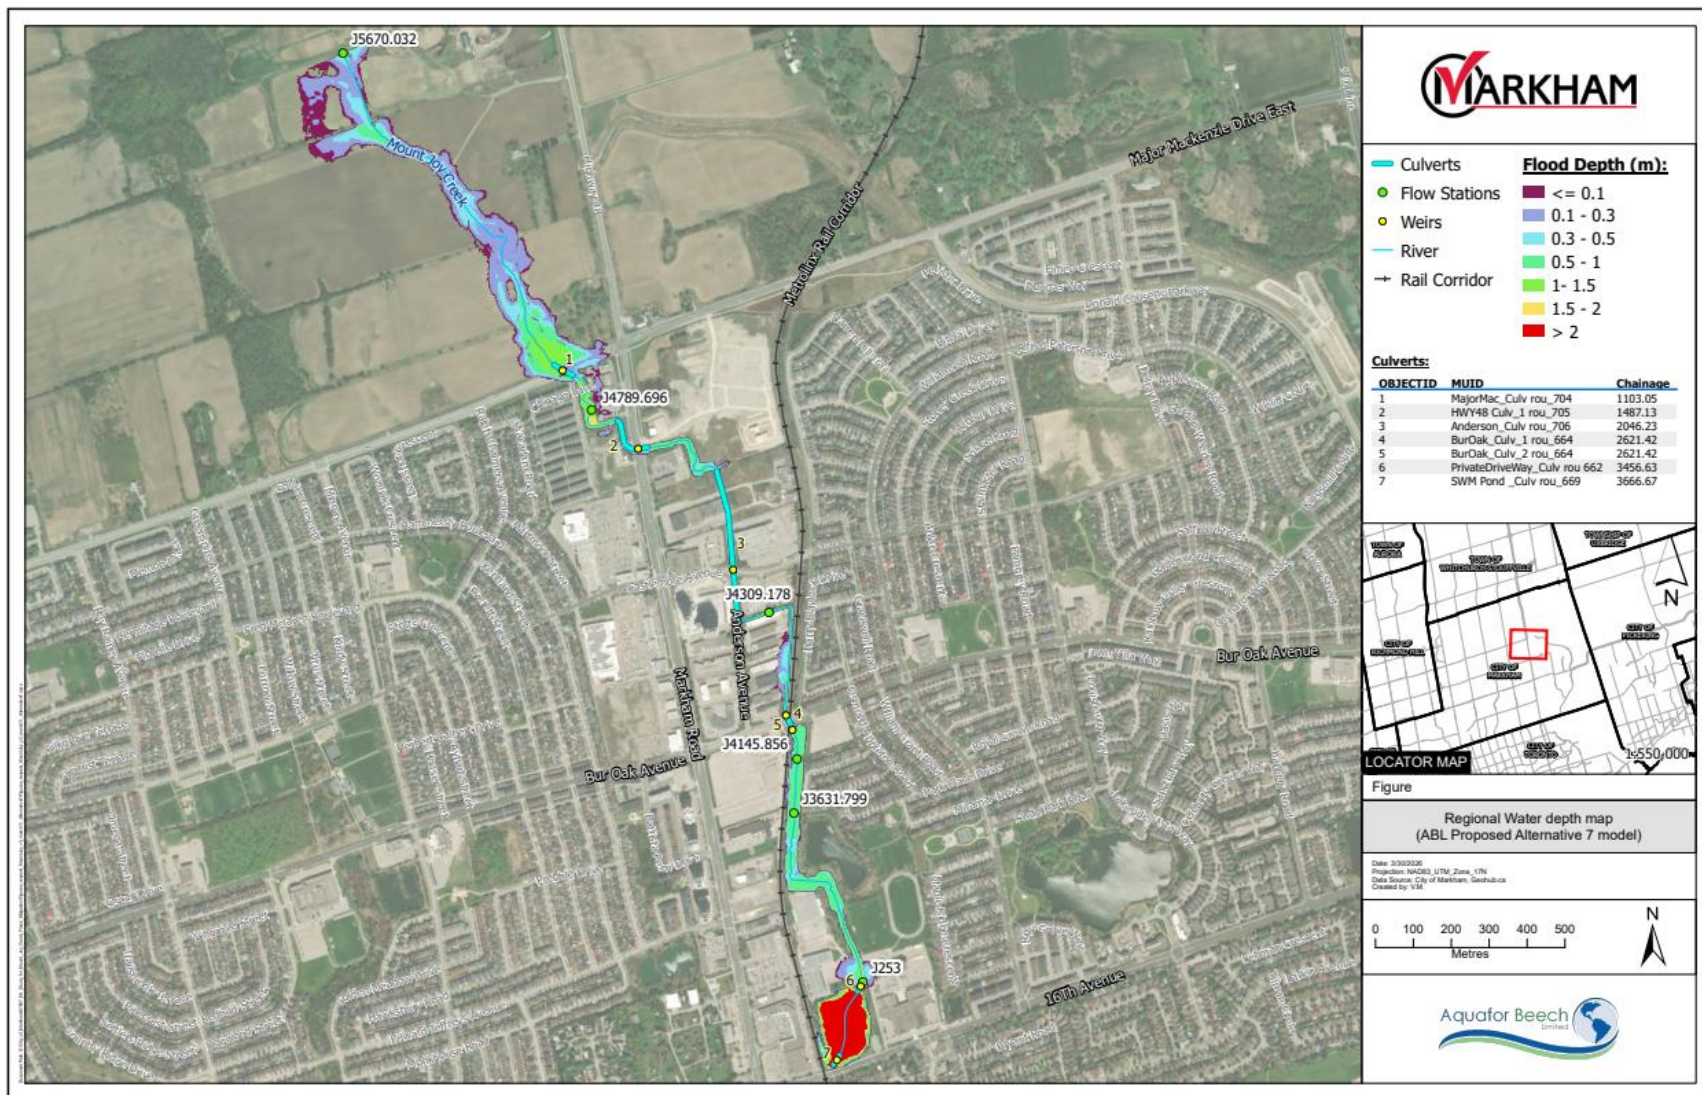
**Figure 4-15: Alternative 7 Culvert Enlargement - Regional Water Depth (m)**

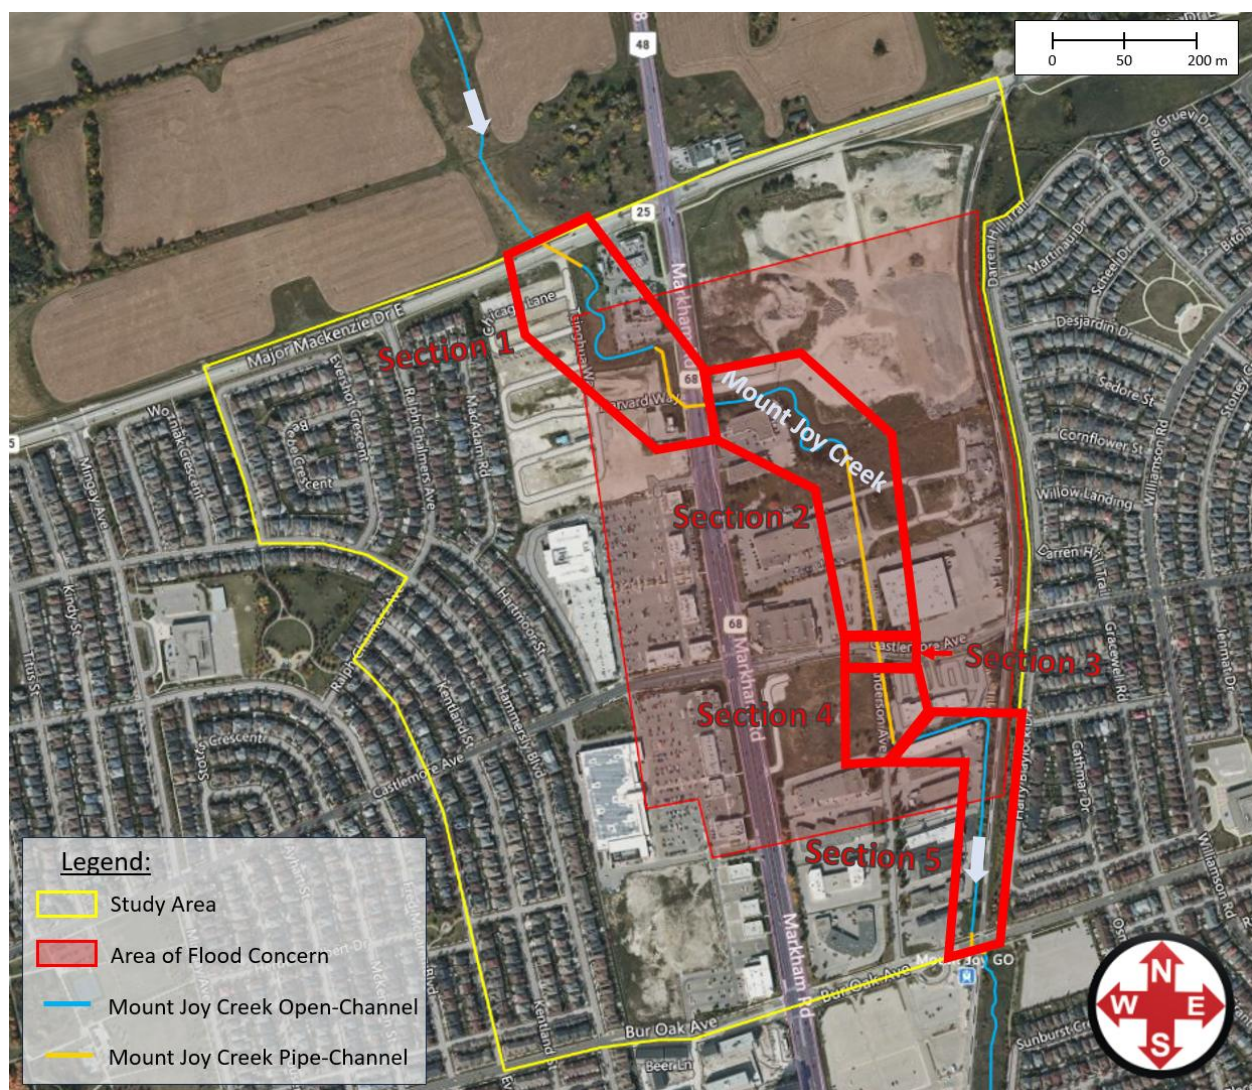
The following section of the report pertains to the constructability review of the alternative. Specifically, the preferred alternative has been broken down into five (5) sections and key aspects of the alternative including alignment and profile, Utility Conflicts and Property Acquisition have been detailed in **Table 4-17** below and a figure showing the location of each Section ID can be seen in **Figure 4-21**.
